TESTING REPORT

N°23TRN673265_Rev.0

Customer Vondom S.L.U.
Customer's address Poligono 6 , 16 Beneixida, 46293
Valencia, Spain
Testing report n° 23TRN673265 Final [] Intermediate []
Revision n° 0
Date 23/05/2023
Title Vondom powder-coated Aluminum. Acetic acid salt spray test
Attachment -

INFORME DE CORROSIÓN EN CÁMARA DE NIEBLA SALINA

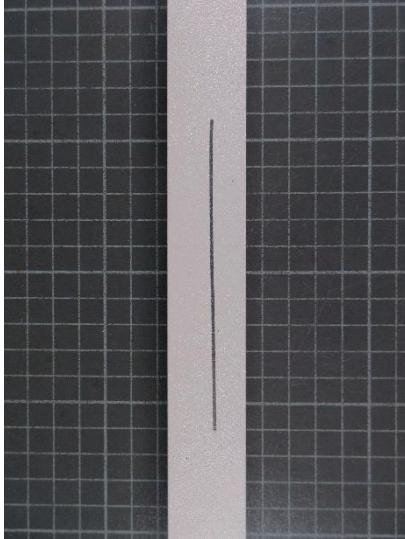
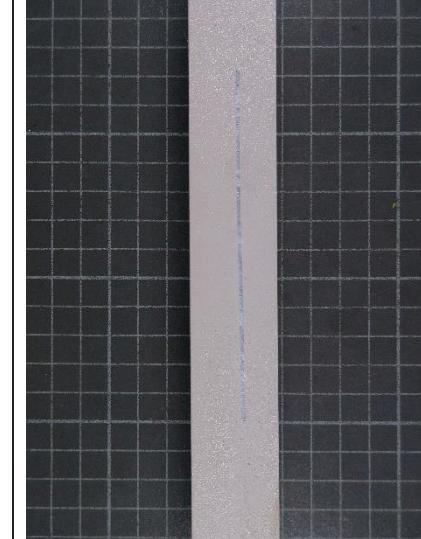
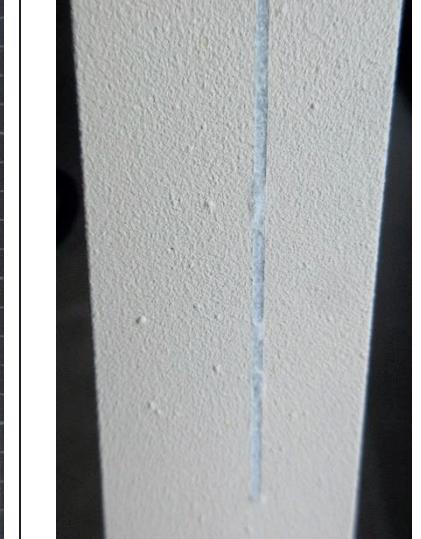
Aluminium profile coated with YD365L 23CTL673265 - 1		
Before the test	After the test	After the test - detail

Internal code	Description	Check (hours)			
		Appearance after test	Blistering ISO 4628-2	Max infiltration from the scribe (mm)	Area of infiltration (mm ²) normalized to 10 cm
23CTL673265 - 1	Aluminium profile coated with YD365L	Blistering on the surface and white oxidation along the scribe	2(S2)	0,0	0
23CTL673265 - 2	Aluminium profile coated with YD365L	Blistering and white oxidation along the scribe	0(S0)	1,0	1
23CTL673265 - 3	Aluminium profile coated with YD365L	No blistering but white oxidation along the scribe	0(S0)	0,0	0
23CTL673265 - 4	Aluminium profile coated with YD365L	Blistering and white oxidation along the scribe	0(S0)	1,5	3

At the end of the test, all the samples showed white oxidation along the scribe. Two of four were affected by infiltration along the scribe with average value of 1,2mm as maximum and 2mm² as area.

Only one sample showed blistering on the surface with a rating of 2(S2).

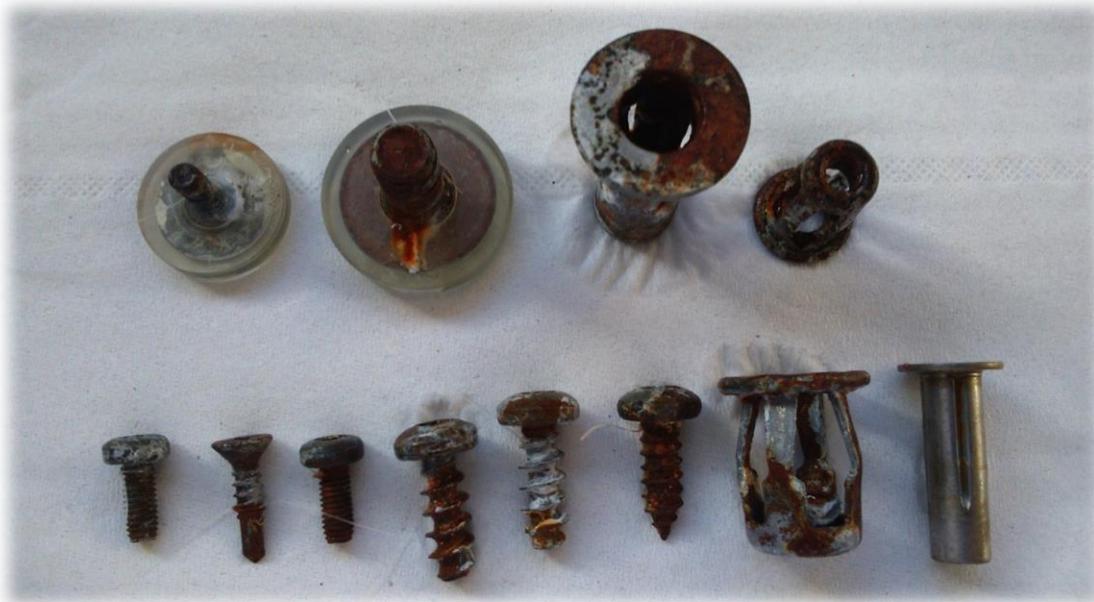
240h en C.N.S.

GRUPO A: PIEZAS ZINCADAS (12 UNIDADES)

24	48	72	96	120	144	168	192	216	240	264	288	312	336	360	384	408	432
A	12																	
B		2																
C		7	4	1	1	1	1	1										
D		3	8	11	11	11	11	11	12	12

- Las piezas zincadas son las que presentan peor resistencia a la corrosión. Seguramente se tratan de piezas zincadas y pasivadas con acabados que tienen buenas propiedades decorativas, brillo y tonalidad, pero proporcionan poca resistencia a la corrosión. En este sentido nos ha llamado la atención que una de las piezas (la situada abajo a la derecha según foto) presenta una mayor resistencia que el resto de su grupo, probablemente porque ha sido tratada con un producto diferente. Cabe, así, destacar que en el mercado existen otro tipo de acabados para zinc (pasivados de alta resistencia y/o sellados) que pueden proporcionar una resistencia a la corrosión mucho mayor.

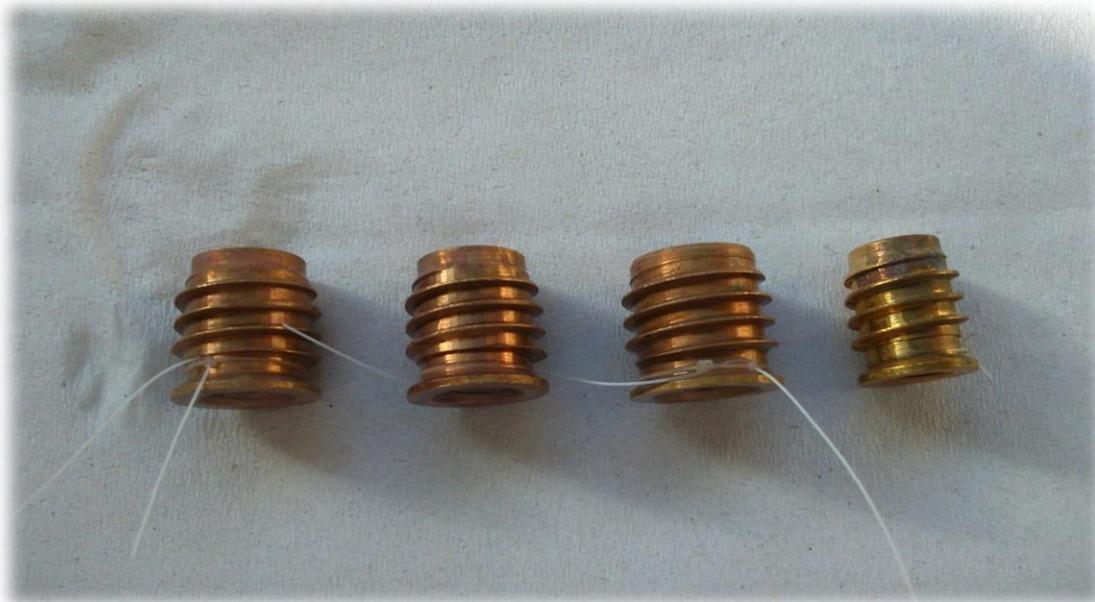
240h en C.N.S

GRUPO C : PIEZAS LATÓN (4 UNIDADES)

24	48	72	96	120	144	168	192	216	240	264	288	312	336	360	384	408	432
A	4	4	4	4	4	4	4	4	4	4								
B																		
C																		
D

NOTA: con el paso de las horas sólo se aprecia una decoloración del metal.

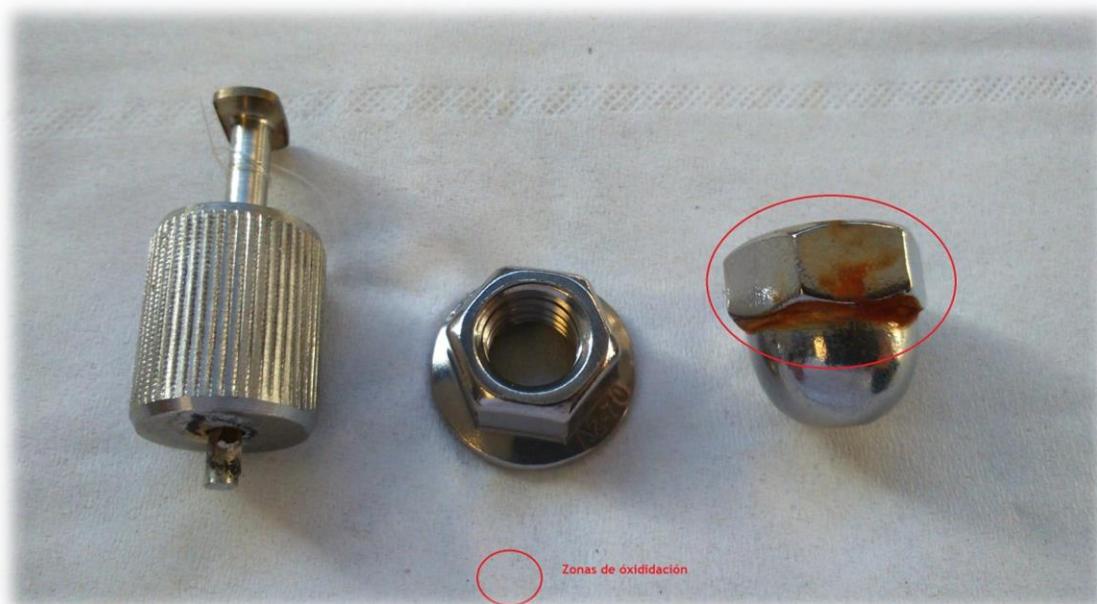
240h en C.N.S

GRUPO D : PIEZAS INOXIDABLE (3 UNIDADES)

24	48	72	96	120	144	168	192	216	240	264	288	312	336	360	384	408	432
A	3	2	2	2	2	2	2	2	2	2								
B																		
C																		
D		1	1	1	1	1	1	1	1	1

- Dos de las tres piezas de inox aguantan las 240h sin oxidación. En una de ellas aparecen puntos de oxidación, se trata de zonas localizadas, no habiendo zonas generalizadas de corrosión en toda la superficie de la pieza, seguramente producida por contaminación de hierro en el momento de su mecanización.
